**Flooding Issues in Bulby, 06 February 2026 – Information provided by Irnham Parish Council**

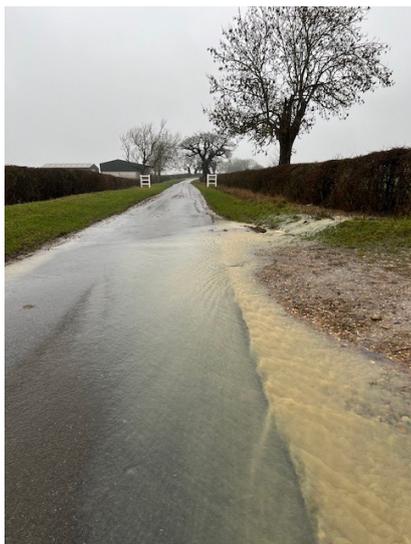
Hawthorpe Road, Bulby.

There are three roads into Bulby. This shows the road off the Kirkby Underwood to Hawthorpe Road. There is no flooding until just above the entrance to Hall Farm, Bulby. A pipe under the field entrance is blocked causing the water to pour down the road. This was reported in December 2024 via FixMyStreet Ref 2825249. We Understood LCC were taking enforcement action and the FixMyStreet state was changed to Closed. Whilst we can appreciate enforcement action takes time the damage caused by the excessive amount of water cascading down the road and eroding the banks and edges of the road is now even more of a problem.

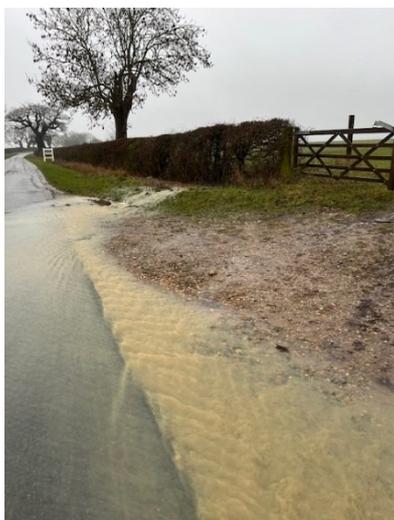
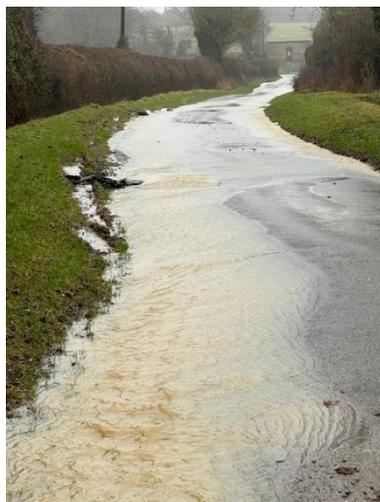
This is the view down to the Pumping Station in Bulby from the gateway shown on the left.

There are 3 drains on the Hawthorpe Road into Bulby. The first two below Hall Farm are working the third is blocked.

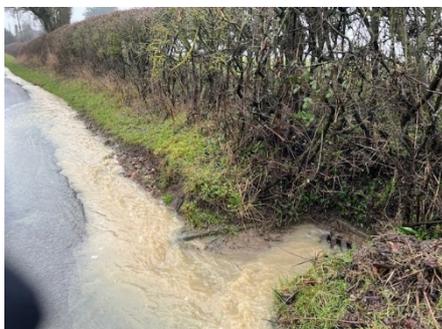
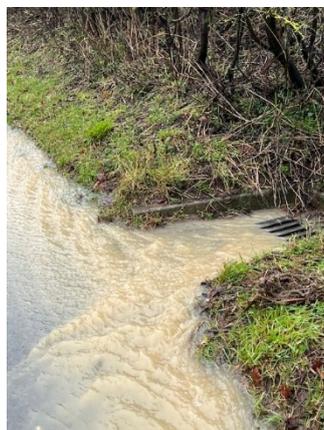
The first two drains below Hall Farm take some water but are set well back from the road.

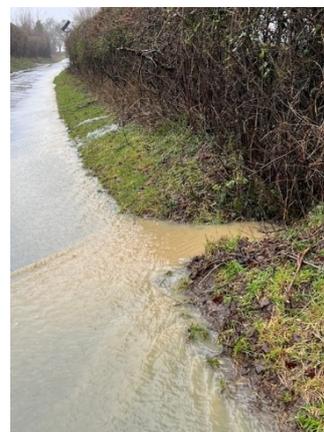
The third drain below Hall Farm is blocked and water flows out of it down the road. Reported recently under Ref 2871299.

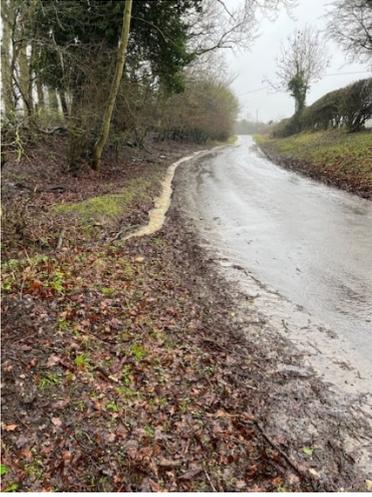
This is the road from Elsthorpe into Bulby. There is no significant water pouring down the road into Bulby from this direction.

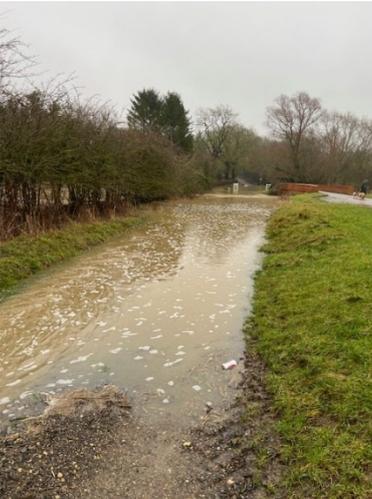
This image shows the entrance to the village by the ford. The bridge over the ford can be reached from the Irnham side but the road the other side is impassable. The 6' depth marker is under water. The following images show the water in the village today 06 February 2026 about 11am.

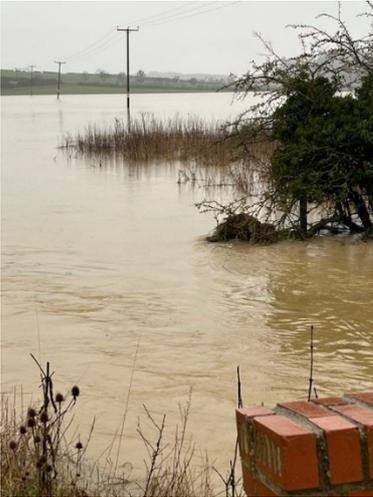
A view from the road bridge adjacent to the ford. The East Glen river has burst its banks.

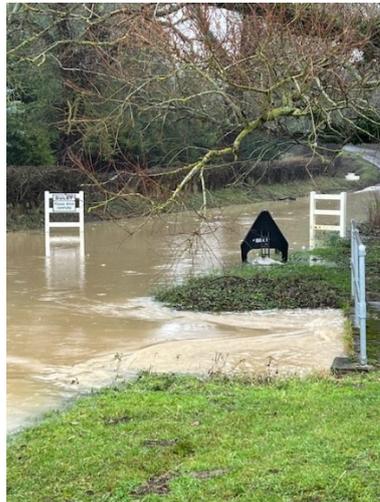
Anyone coming over the bridge is faced with a flood. The foot bridge is almost under water.

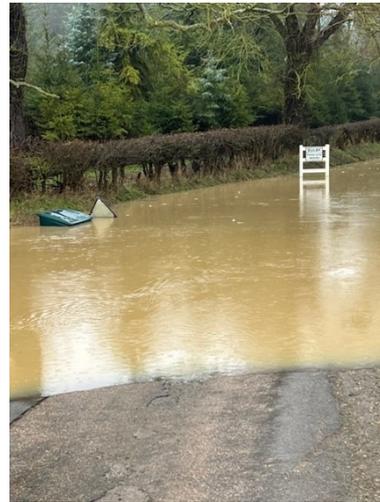
The grit bin on the bank is almost under water.

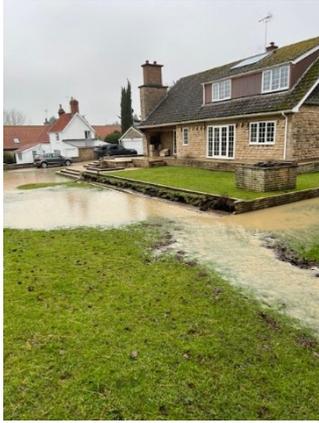
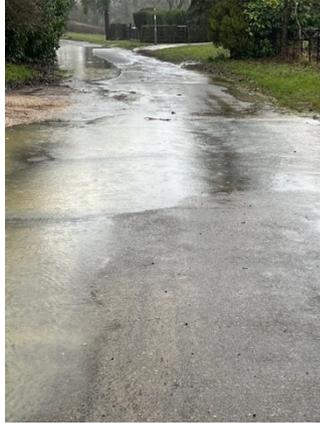
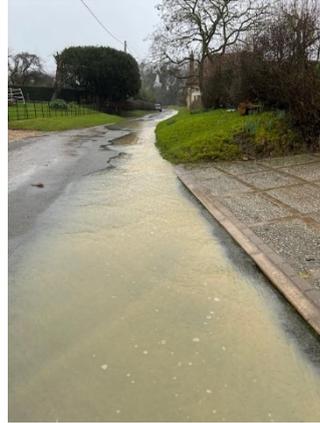
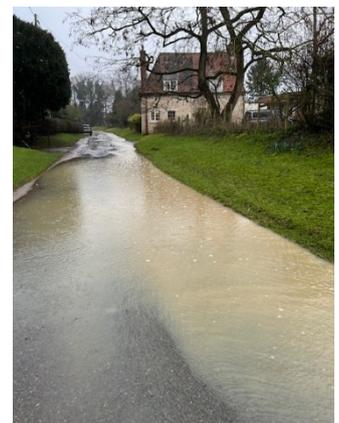
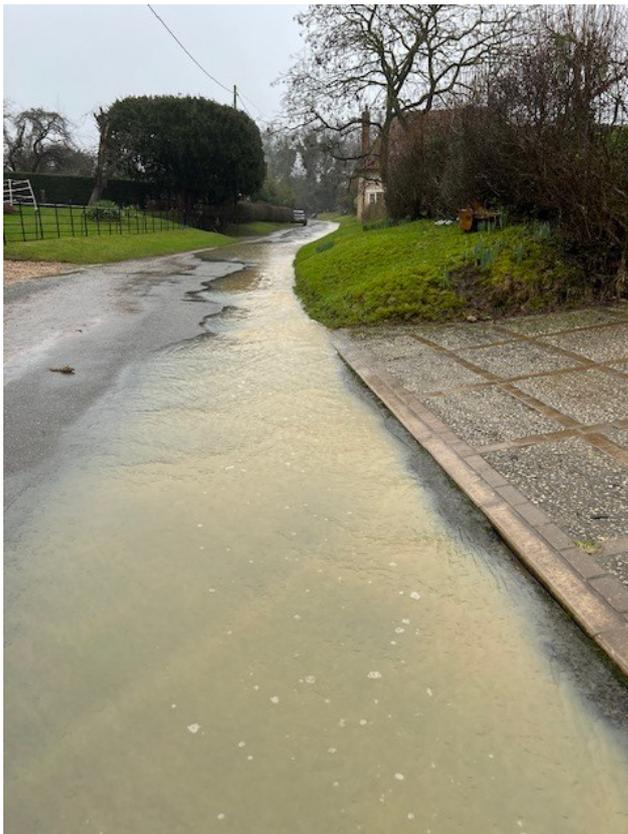
Flooding in the main street of Bulby is now much worse since the two drains, one outside Keepers Cottage and one outside Fallowfield House have become blocked. (Reported under Ref 2871508 and Ref 2871515) The only drain working in the upper part of the village is the one outside Linden House.

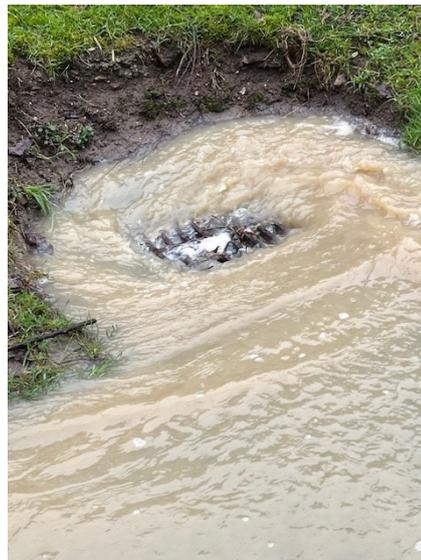
We regularly clear debris washed down from this grid to help prevent flooding of properties down the village towards the ford.
